AIR SERVICE INFORMATION CIRCULAR

August 15, 1922

STATIC TEST OF THOMAS-MORSE MB-6 AIRPLANE

Prepared by E. R. Weaver
Engineering Division, Air Service
McCook Field, Dayton, Ohio
May 2, 1922

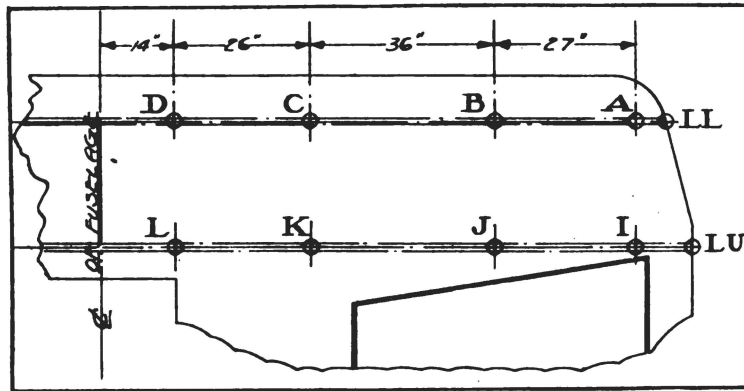
FIG. 10.—Deflection chart at high incidence.

Failure.

Left rear strut fitting bolt sheared first. This caused left rear strut to fail.

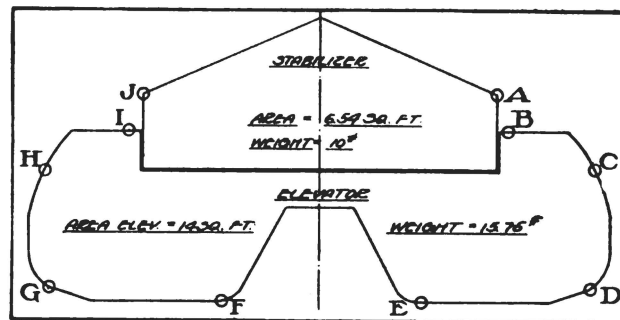
FIG. 15.—Loading schedule and results of test of horizontal tail surfaces.

Figure 15 shows the deflections and results of the test. The horizontal tail surface stood the test without signs of failure.

The required load per square foot for the stabilizer and elevator is 35 pounds. At this load the cross member sup-

porting the control stick showed a torsional deflection of one-half inch. It is evident that this member should be heavier.

Redesign the cross member supporting the front part of the pilot's seat and the control stick so as to eliminate excessive deflection when tail surfaces are supporting their required load.

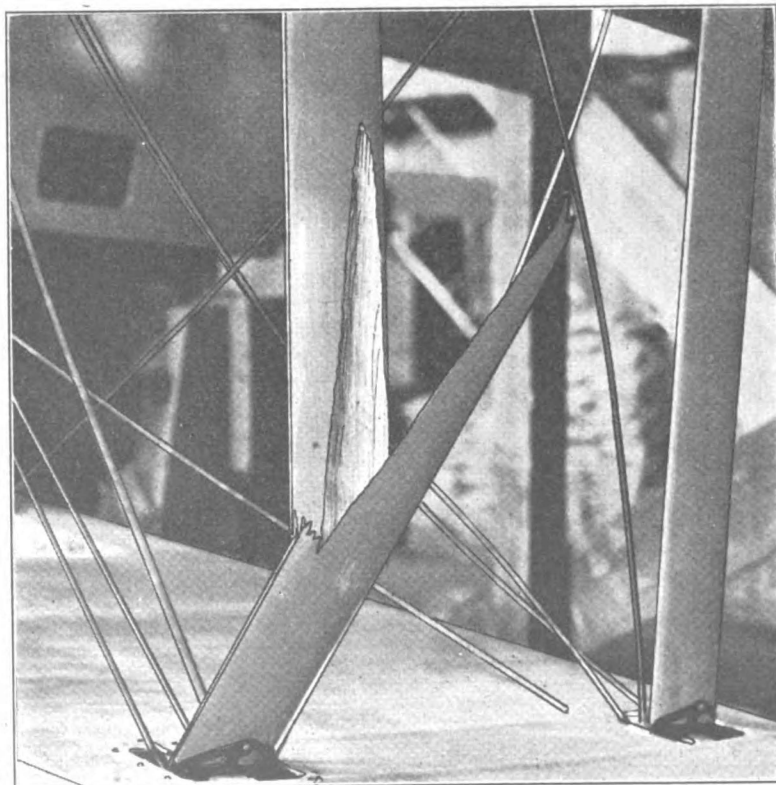
FIG. 25.—Strut failure.

The required load factor for the high-incidence test was 8.5. The wings supported this load satisfactorily. At a load factor of 9 the left rear strut failed in compression when the strut fitting bolt sheared.

Figure 25 is a photograph of the strut failure.

Examination of the strut failure revealed diagonal grain.

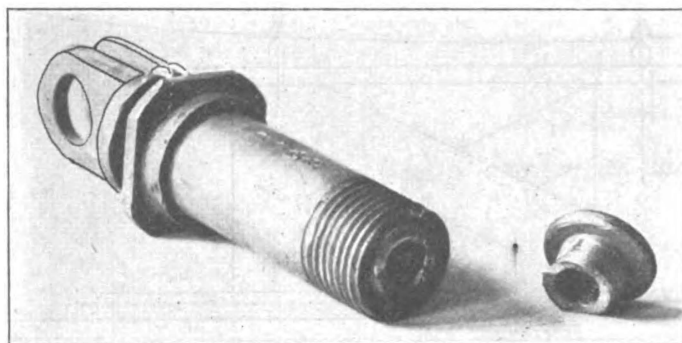
FIG. 26.—Strut fitting bolt.

Figure 26 is a photograph of the strut fitting.

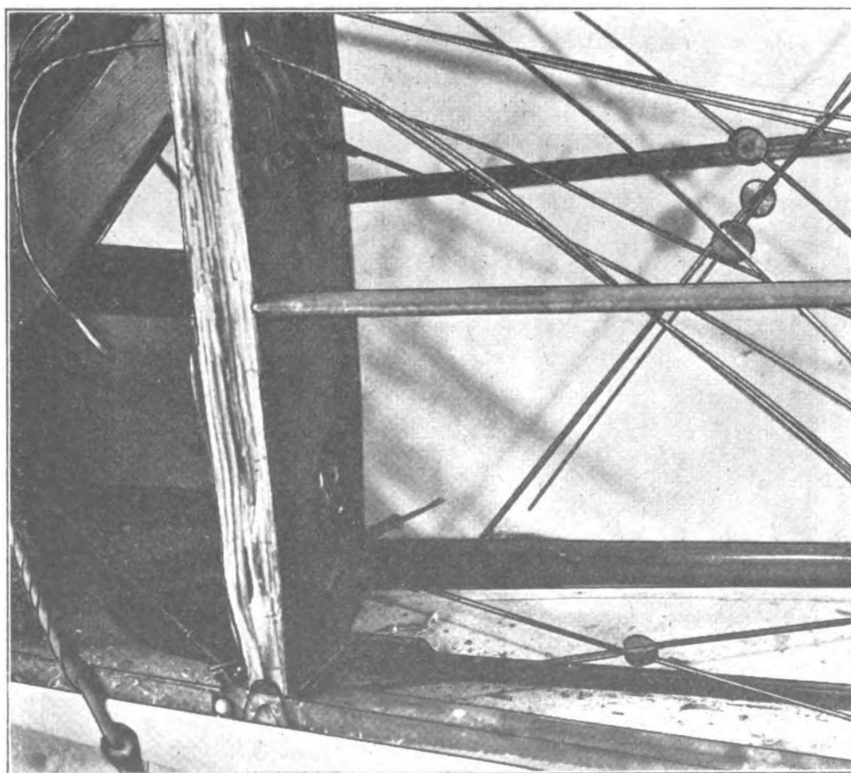
FIG. 27.—Fuselage failure.

The fuselage structure was required to support a load factor of 7. The engine bearers supported a load factor of 7.5 without any signs of failure. With load factor of 11 on the tail the wires in the fourth bay to the rear of the pilot's cockpit failed.

Figure 27 is a photograph of the failure.

The longerons showed much distortion and small cracks, developed in them. After the load was removed the longerons showed a permanent set.

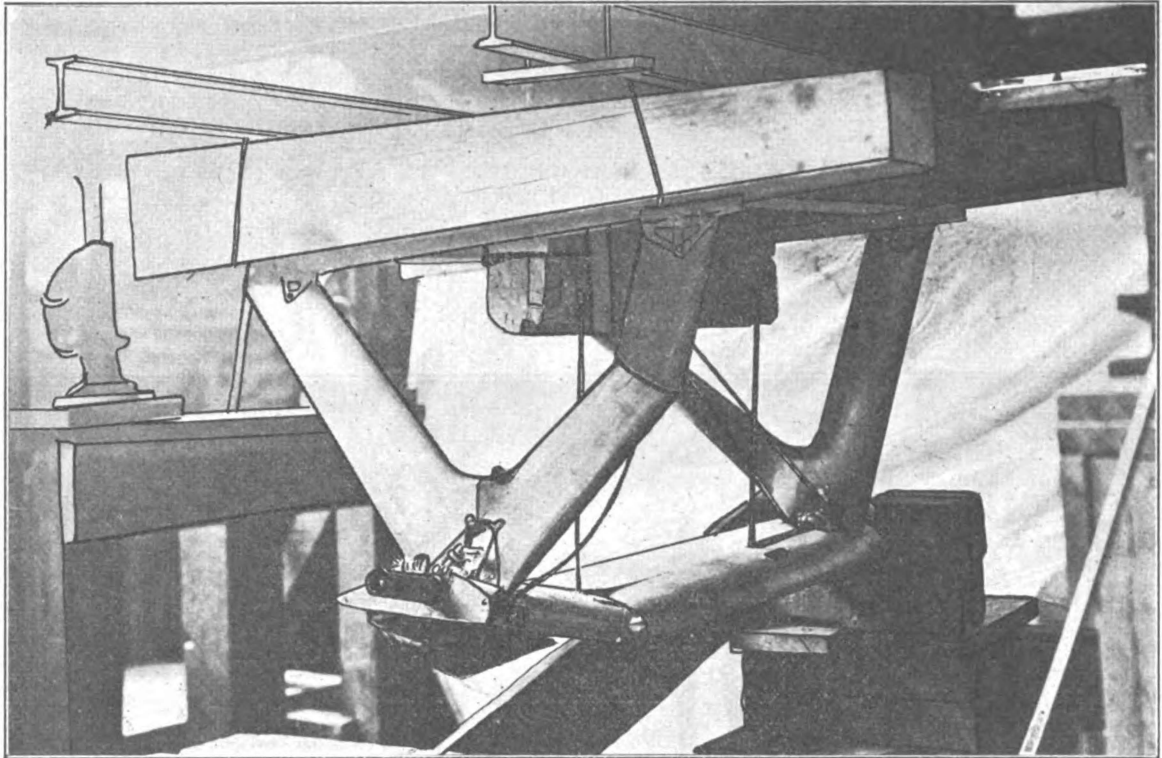
FIG. 28.—Landing chassis failure.

The required load factor for the landing chassis was 6. The chassis supported this load without signs of failure. At a load factor of 8 the right front strut failed.

Figure 28 is a photograph of the failure.

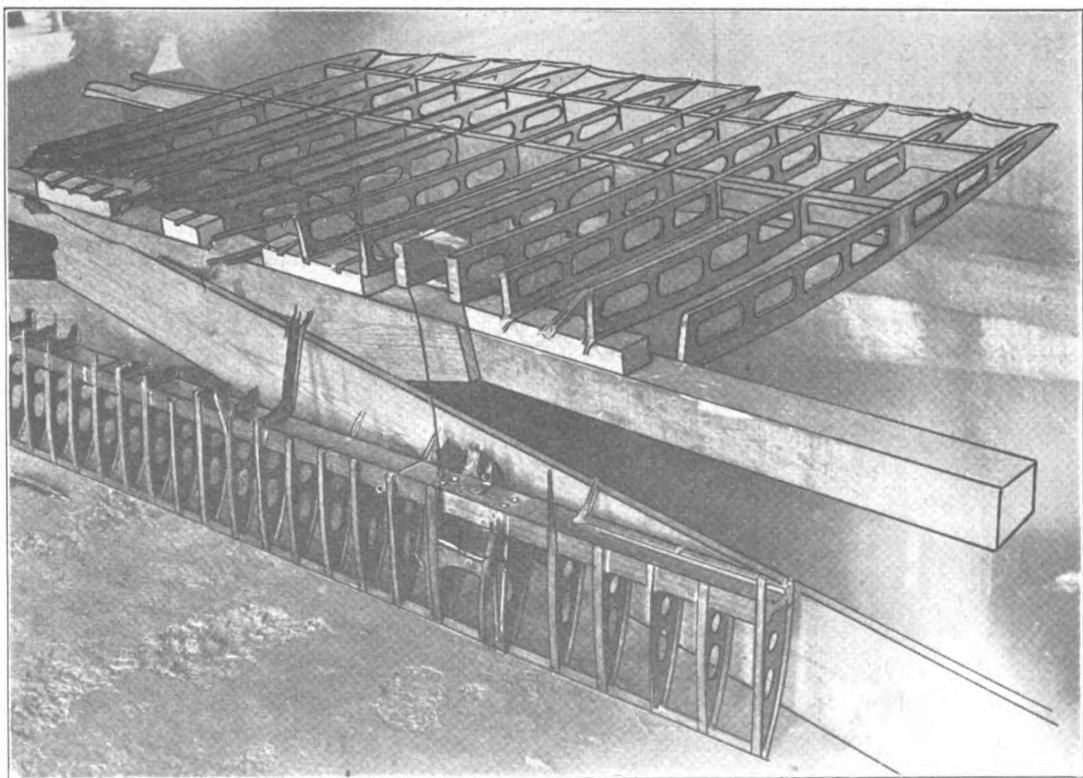
FIG. 29.—Leading edge failure.

At a load of 3,300 pounds the cap strips failed and the leading edge portion broke off at the rear side of the front spar. This tore the front spar from the rest of the wing structure.

Figure 29 shows the nature of the failure.

The leading edge of the MB-6 wing is very satisfactory structurally since the factor of failure was 20.8, the required load factor for this test being 14.

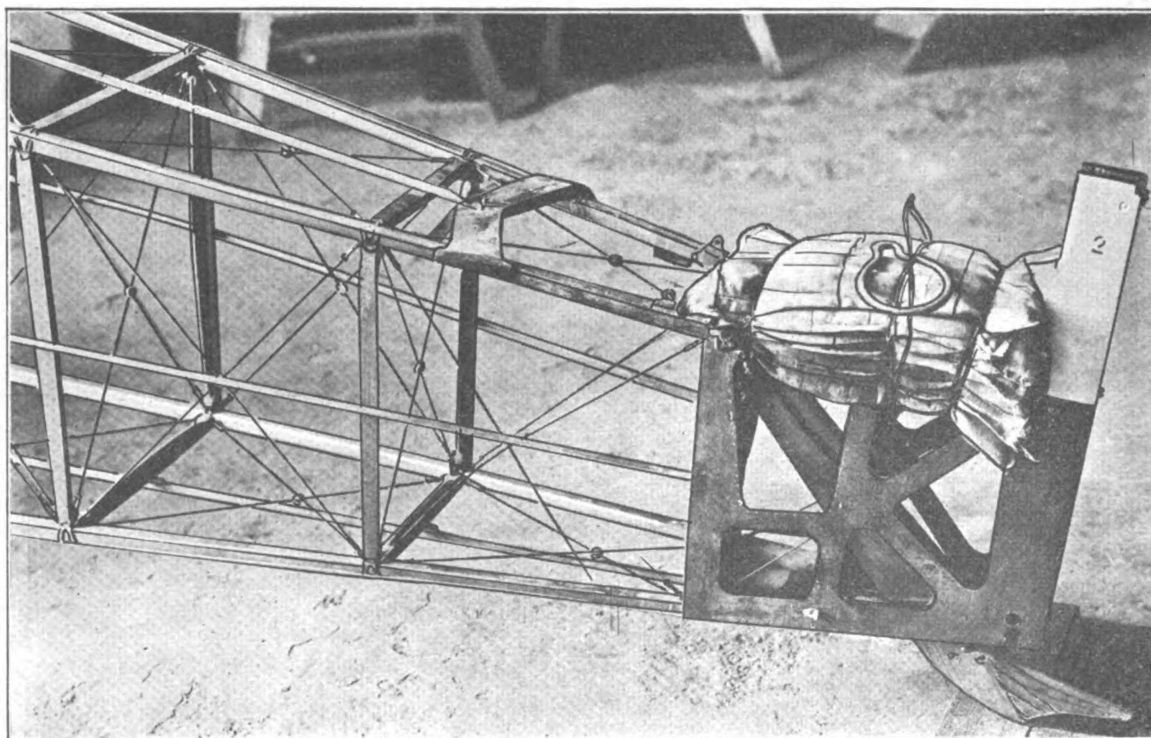
FIG. 30.—Tail skid failure.

The tail skid withstood the first drop which was through a distance of 6 inches. The failure occurred on the next drop which was through a distance of 12 inches. Figure 30 is a photograph of the failure.

No deflection of the shock absorber elastic was noticed during the test.

The tail skid is weak and poorly designed.

Redesign tail skid and shock absorber to withstand drop test through distance of 36 inches.
